# TESTS OF PRESTRESSED CONCRETE BEAM SPLICES

SEPTEMBER 1969 - NUMBER 22

JOINT HIGHWAY RESEARCH PROJECT  
PURDUE UNIVERSITY AND  
INDIANA STATE HIGHWAY COMMISSION

Final Report

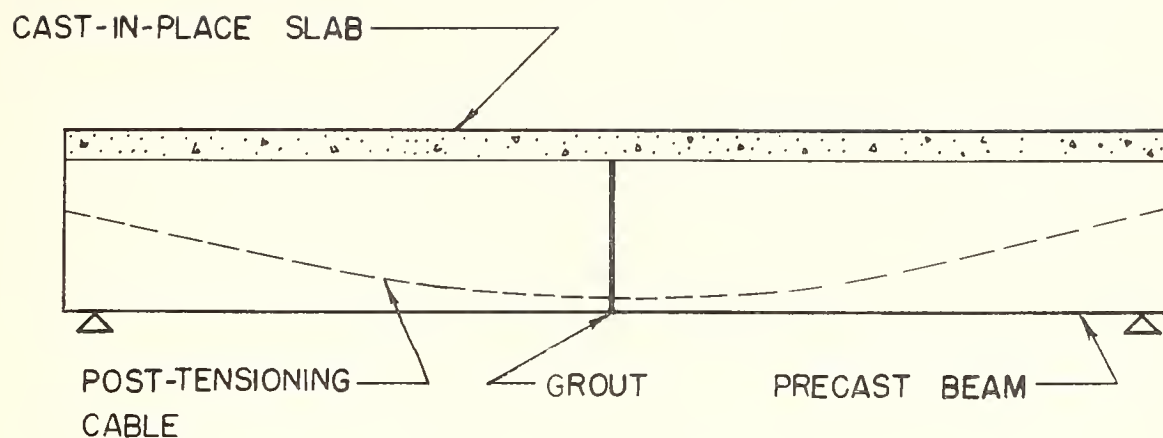
FIGURE 1. POST-TENSIONED SPLICE - GENERAL ARRANGEMENT

One type of splicing situation which may arise is indicated in Figure 1. The use illustrated is that of a simple span beam, spliced in the region of high bending moment. (There are other possible configurations where this splice may prove useful.)

The splice connects two precast beams by using post-tensioning cables threaded through ducts in the adjoining members. A thin layer of grout between the two beams is used to provide an even bearing surface. The beams are temporarily shored while the cables are threaded, the grout packed and a cast-in-place deck slab placed. The cables are then stressed, permitting removal of the shores. Grouting of the void space bonds the cables to the beams. The post-tensioning cables provide the connecting link between the precast beams. The precast beams contain a minor amount of pre-tensioning steel to prevent cracking during handling and transportation.

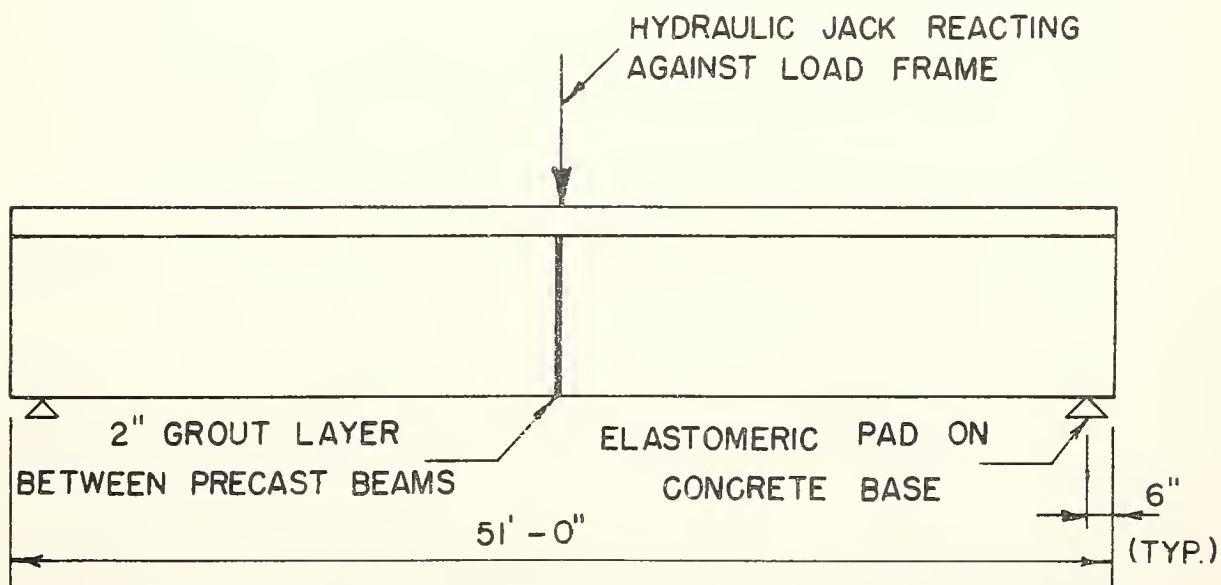
FIGURE 2. POST-TENSIONED SPLICE - LOAD ARRANGEMENT

The specimen was loaded through a hydraulic jack at the centerline of the span. The jack reacted against a steel test frame bolted to the foundation. Elastomeric bearing pads were used at the end bearings and between the jack and the slab. The jack had a capacity of 400 kips, while the test frame was rated at about 200 kips. The jack had been pre-calibrated for correspondence between gage pressure and applied load.

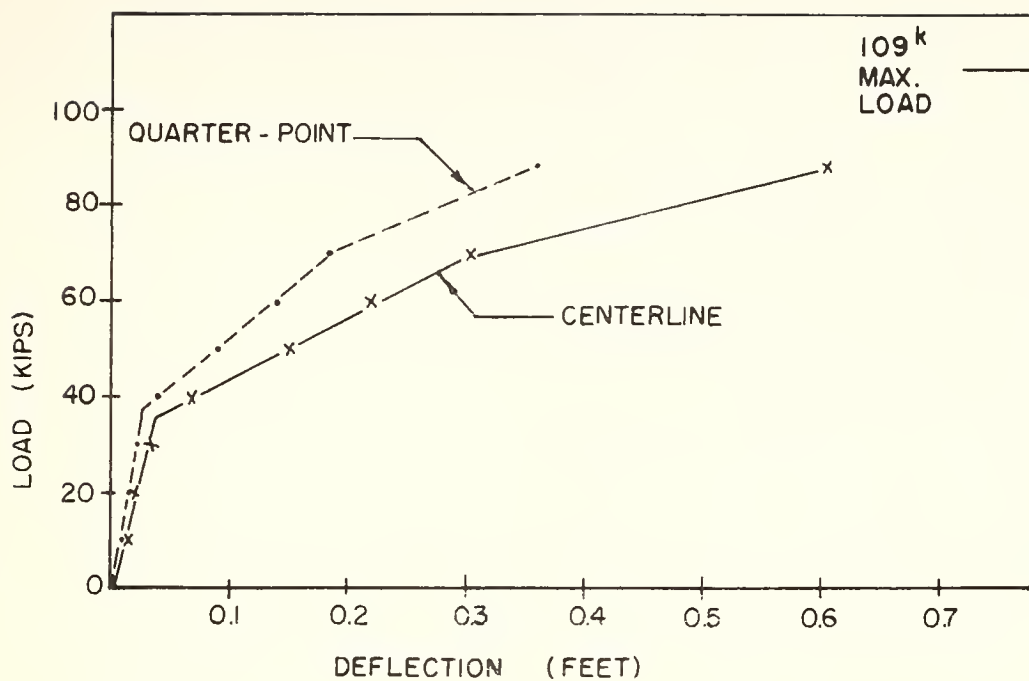
FIGURE 4. POST-TENSIONED SPLICE — LOAD VS. DEFLECTION

Vertical deflections were measured at the centerline and quarterpoints of the span using a surveyor's level. Short pieces of level rod were attached to the beam at the deflection points. Readings were taken at each load level with an accuracy of 0.005 feet or about 1/16 inch. Deflections at the quarter points were essentially symmetrical and an average value of these readings is used on the accompanying plots. Figure 4 gives the load-deflection response of the beam.

The member exhibited two basically linear load deflection ranges - one below 30 kips and a second region of reduced stiffness above about 40 kips.

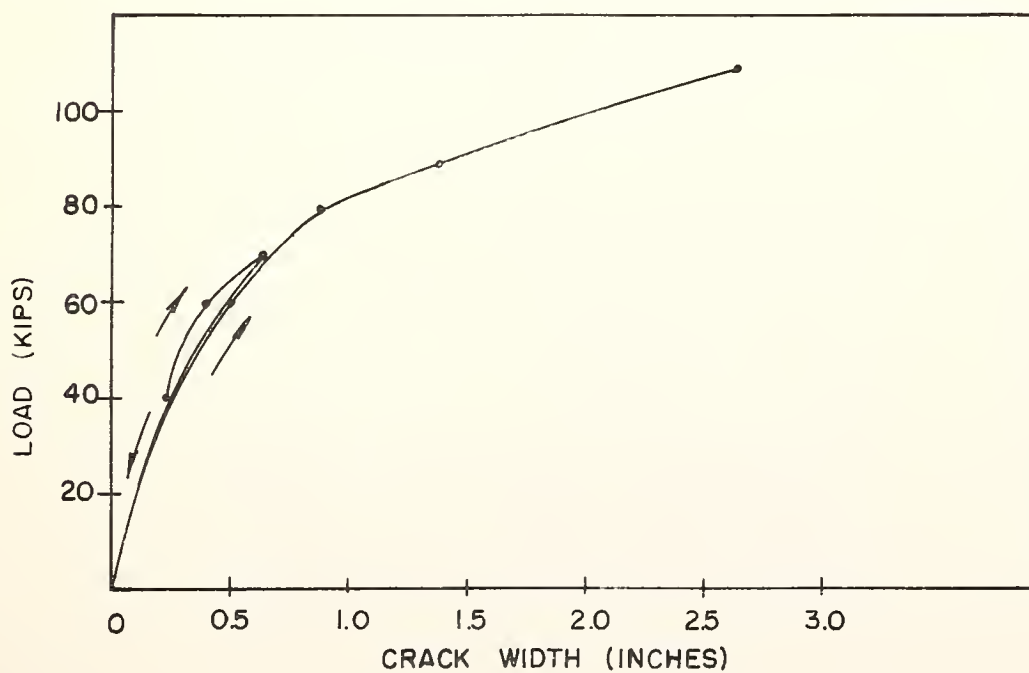
FIGURE 5. POST-TENSIONED SPLICE — LOAD VS. CRACK WIDTH

Cracking first appeared at a load of 20 kips and was of hairline width. At 30 kips the crack had progressed to approximately the mid-depth of the web. As the applied load increased and the crack width became significant, the width was measured with a hand rule to the nearest 1/16 inch. Figure 5 shows the load-crack width relation observed in the test.

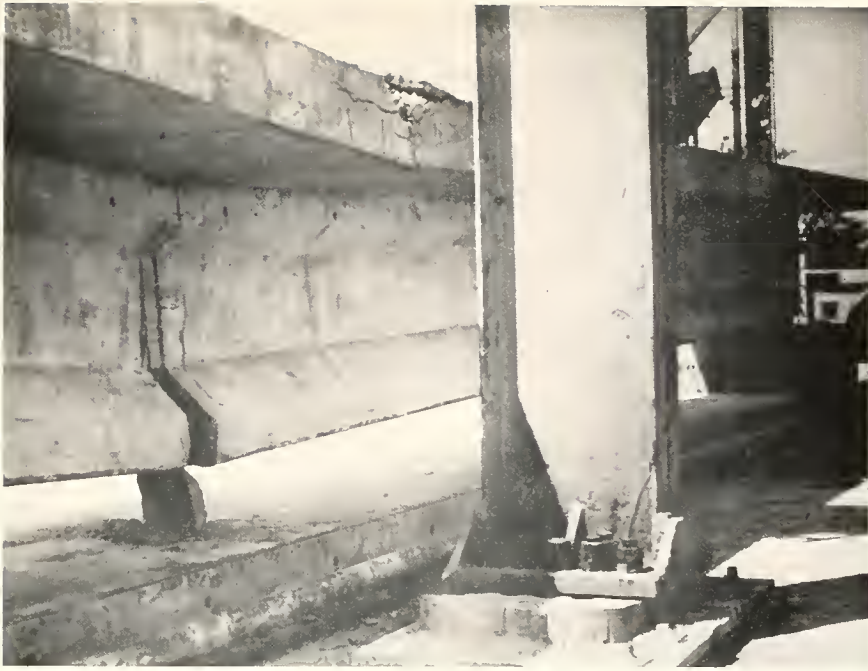
FIGURE 6. ELEVATION VIEW OF POST-TENSIONED SPLICE AT FAILURE

Actual failure of the beam came at a load of 109 kips. The beam would not accept greater load and deflected until the jack reached maximum extension. During this time the crack widened on the tension side and gradual progressive crushing of the concrete occurred on the top fibers. Deflection of about 0.6 foot at the centerline was obtained and crack width was about  $2 \frac{5}{8}$  inches. Figure 6 shows an elevation view of the splice region of the beam at failure, while Figure 7 is a close up view of the splice itself. A portion of the grout layer separated completely from the beam and dropped out.

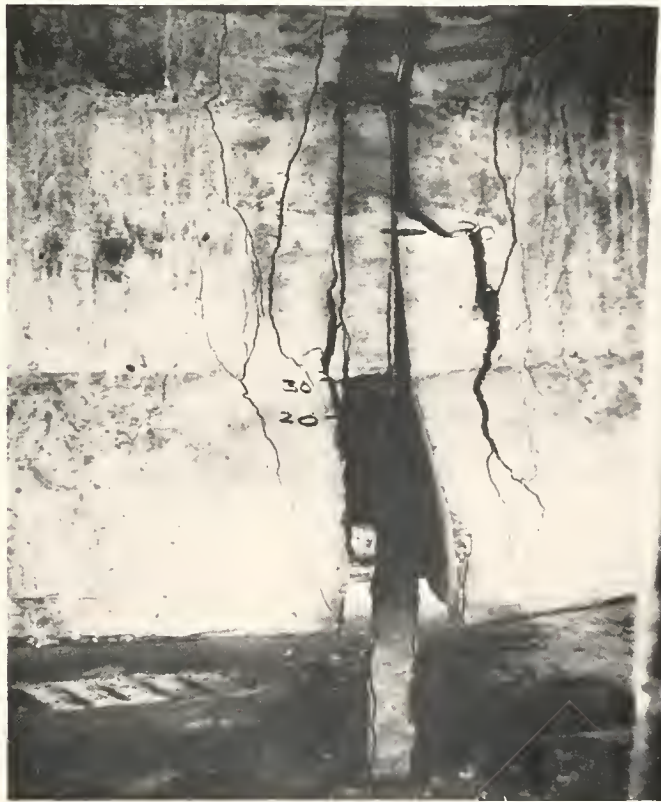
FIGURE 7. CLOSEUP VIEW OF POST-TENSIONED SPLICE AT FAILURE

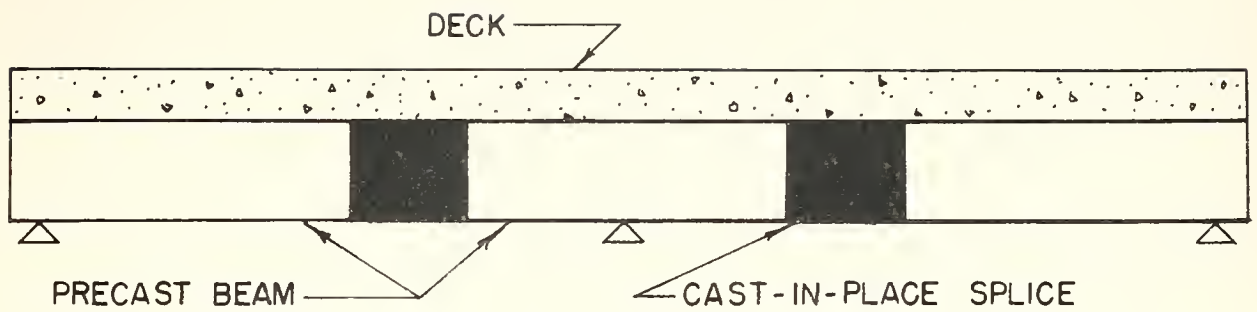
FIGURE 8. CAST-IN-PLACE SPLICE — GENERAL ARRANGEMENT

Construction of continuous spans by splicing several units is very often done by placing the splice near a point of inflection, as illustrated in Figure 8. The concept may be easily extended to multiple spans. The splice would normally be used in regions of relatively small bending moment, but would be subjected to fairly high shears.

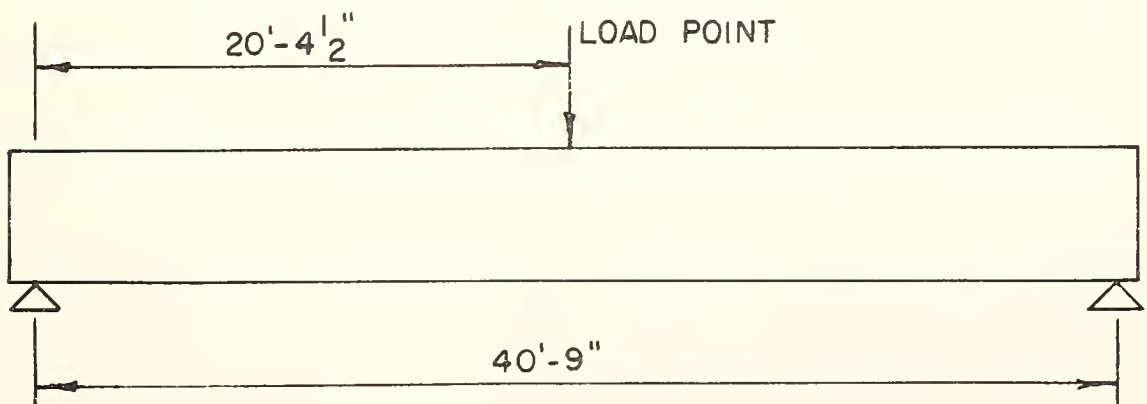
FIGURE 9. CAST-IN-PLACE SPLICE — BEAM ELEVATION

The test specimen had an overall length of 43'-0". Loading arrangement and span length are shown in Figure 9. The cast-in-place splice was placed near the quarter-point of the span. Figures 10 and 11 show the details of the precast beam. Figure 12 shows the details of the cast-in-place joint.

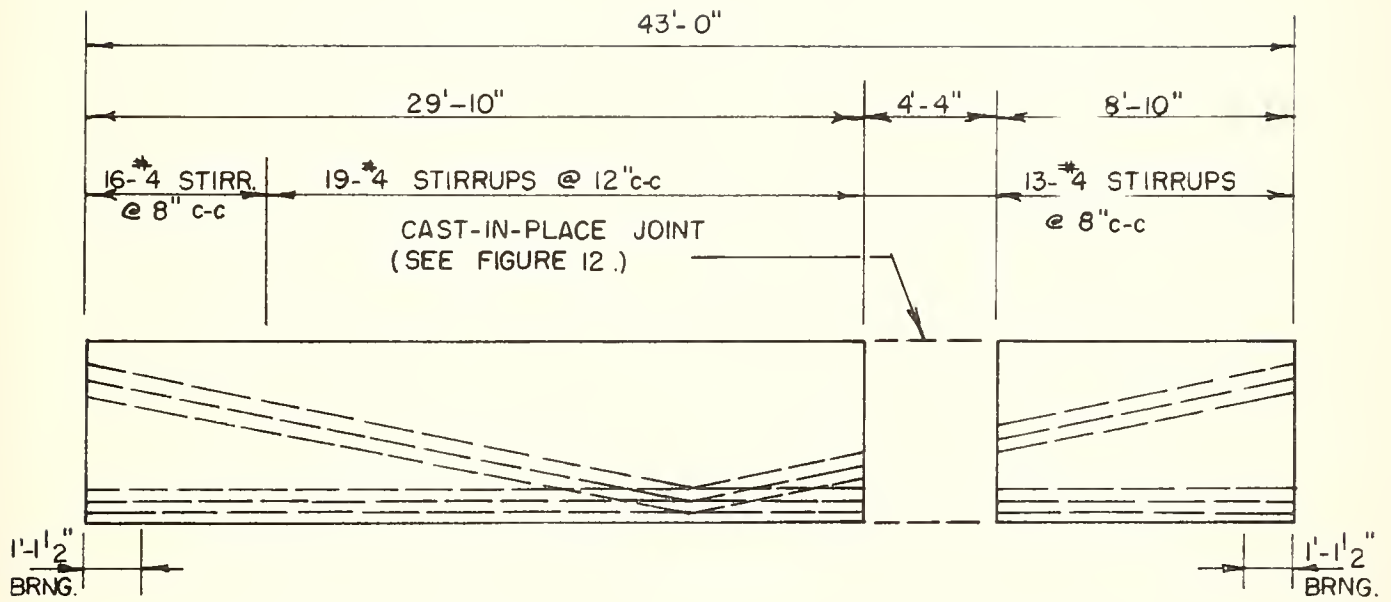
FIGURE 10. CAST-IN-PLACE SPLICE — BEAM ELEVATION

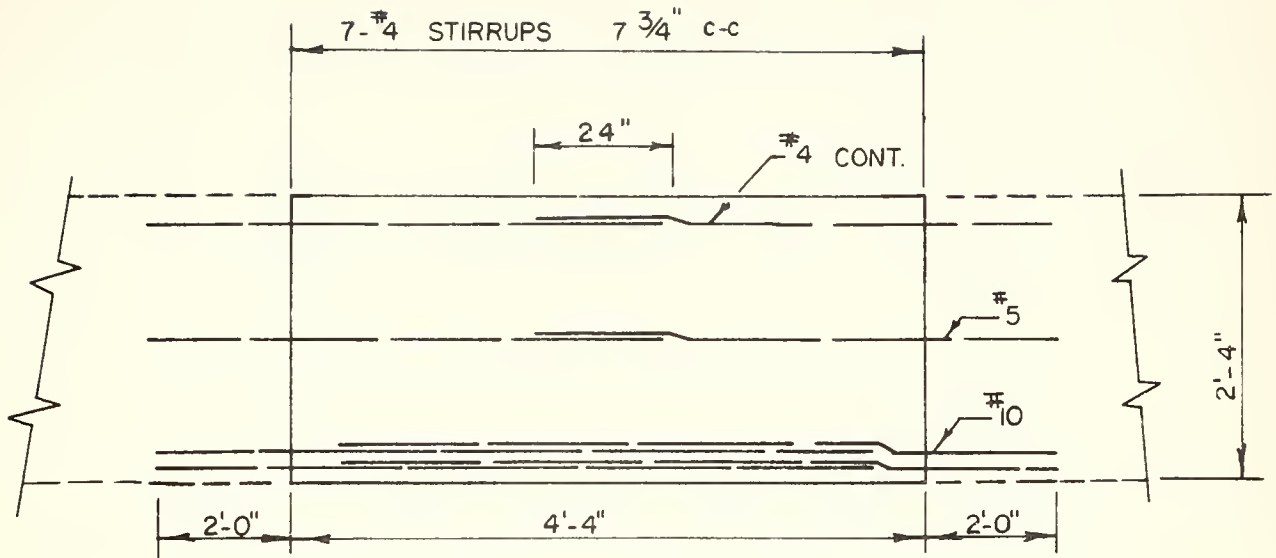
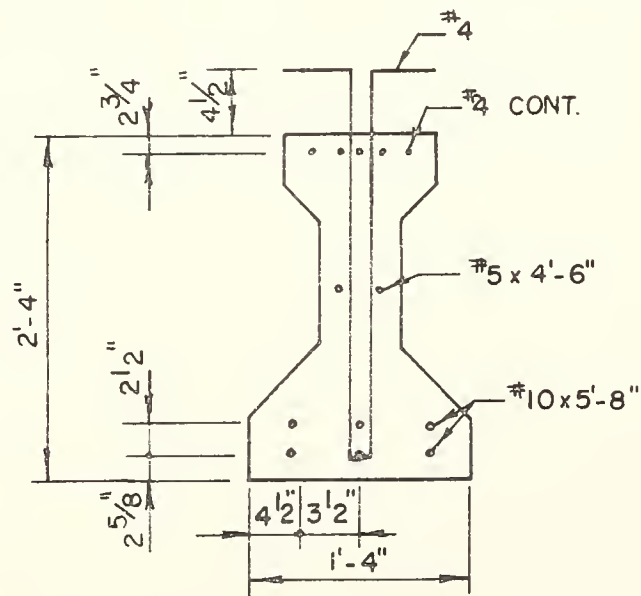
FIGURE 12. CAST-IN-PLACE JOINT DETAILS

(A) ELEVATION

(B) JOINT CROSS SECTION

Construction of the test beam was made by forming the precast elements in a prestressing bed and using a blackout in the splice region. Mild steel bars (embedded 2'-0" into the precast beam) projected through the blackout area. The precast elements were pre-tensioned with straight and deflected cables which ran continuously through the blackout. After curing of the precast elements, the pretensioning cables were cut off at each end of the precast elements. The remainder of the splice reinforcement was then placed. Beams were cast on April 24 and the splice was placed on April 29. Slab concrete was placed on April 30. The member was tested on May 15.

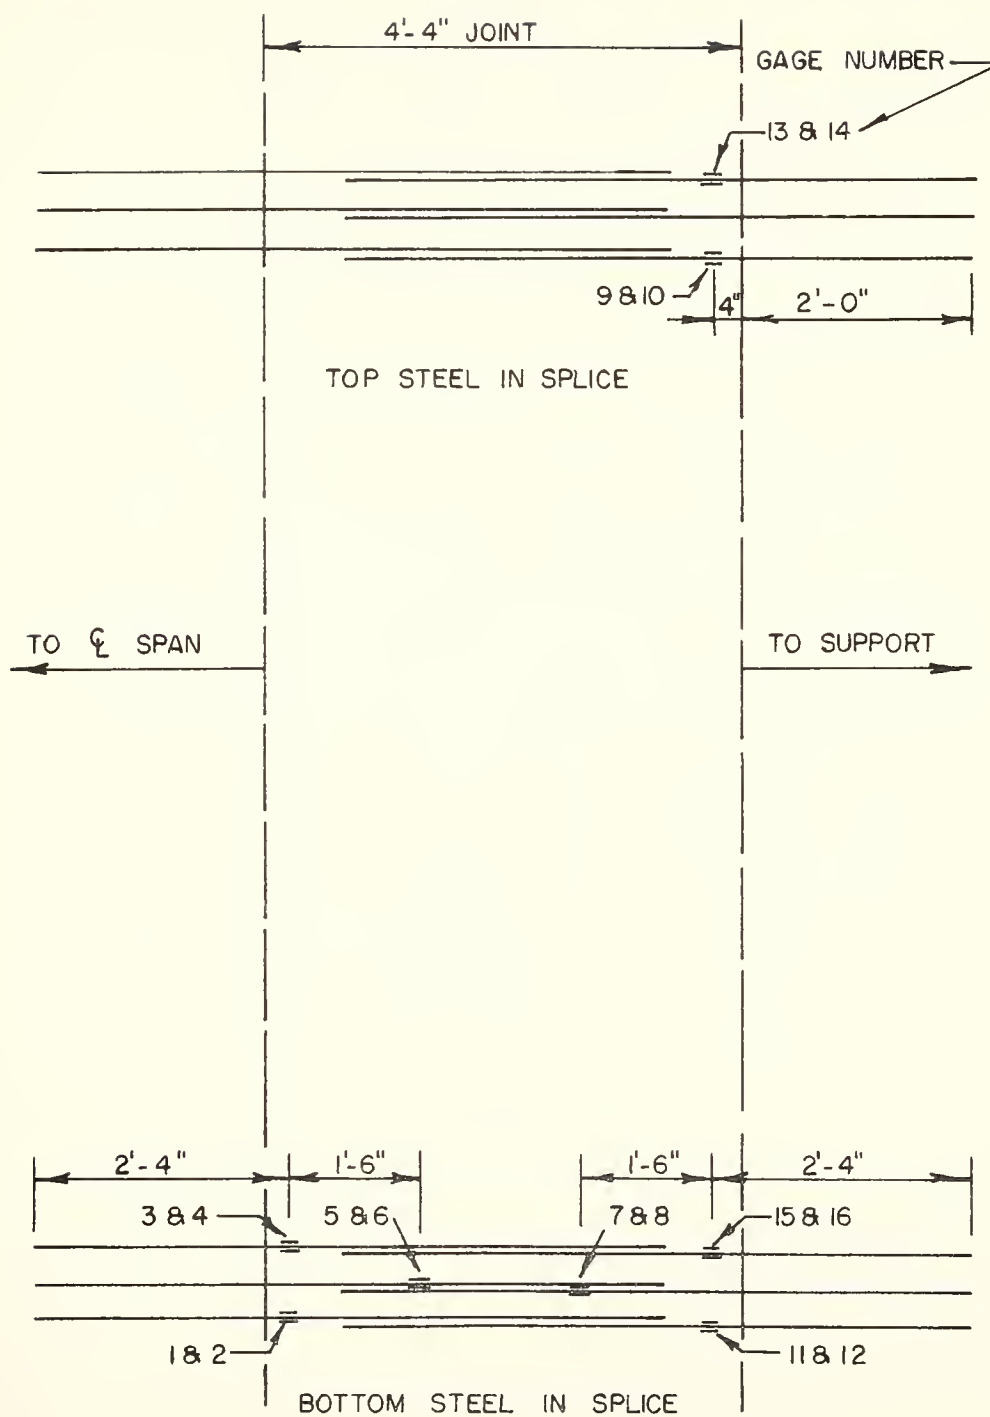
FIGURE 13. CAST-IN-PLACE JOINT — STRAIN GAGE LOCATIONS

The member was tested as a simple beam having a span length of 40'-9", with a concentrated load at the center of the span. The loading arrangement caused high shear at the splice, along with a relatively high bending moment while this condition would rarely occur in field usage, it is certainly a more stringent test of the splice. Thus, a large amount of mild steel was placed in the splice to carry the anticipated bending moment. Electric strain gages were placed on the mild steel bars at locations shown in Figure 13.

Sixteen metal film strain gages were attached to the mild steel splice bars in pairs at the points indicated in Figure 13. Gage reference numbers are also designated in the figure. The gages were temperature compensated for steel. A dummy gage on a steel bar embedded in a concrete cylinder was used; three-wire leads to each gage minimized temperature effects due to the lead wire lengths. Gages were waterproofed with an epoxy compound and a technique which disturbed only a small portion of the bond surface of the bar.

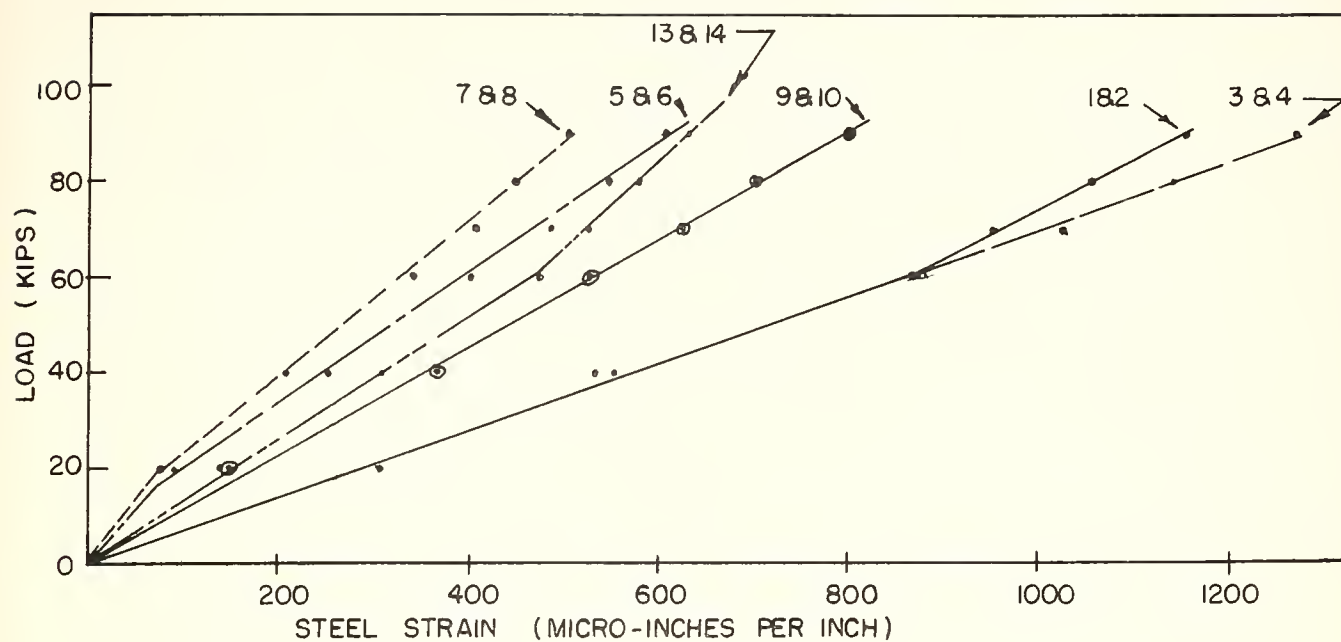
FIGURE 14. CAST-IN-PLACE SPLICE — LOAD VS. STEEL STRAINS

The strain data obtained are given in Table 3. Figure 14 is a plot of load versus steel strain for the various gages. Each gage strain plotted is the average of two gages at the same location, one each on the top and bottom of the bar. Thus gages 1 and 2 are averaged, as are 3 and 4, etc.

Strains in the mild steel at the splice were essentially linear. Elastic or straight-line theory calculations predicted strains within about 15% accuracy, indicating nothing unusual occurred in the splice. The beam failed prior to yielding of any of the splice steel.

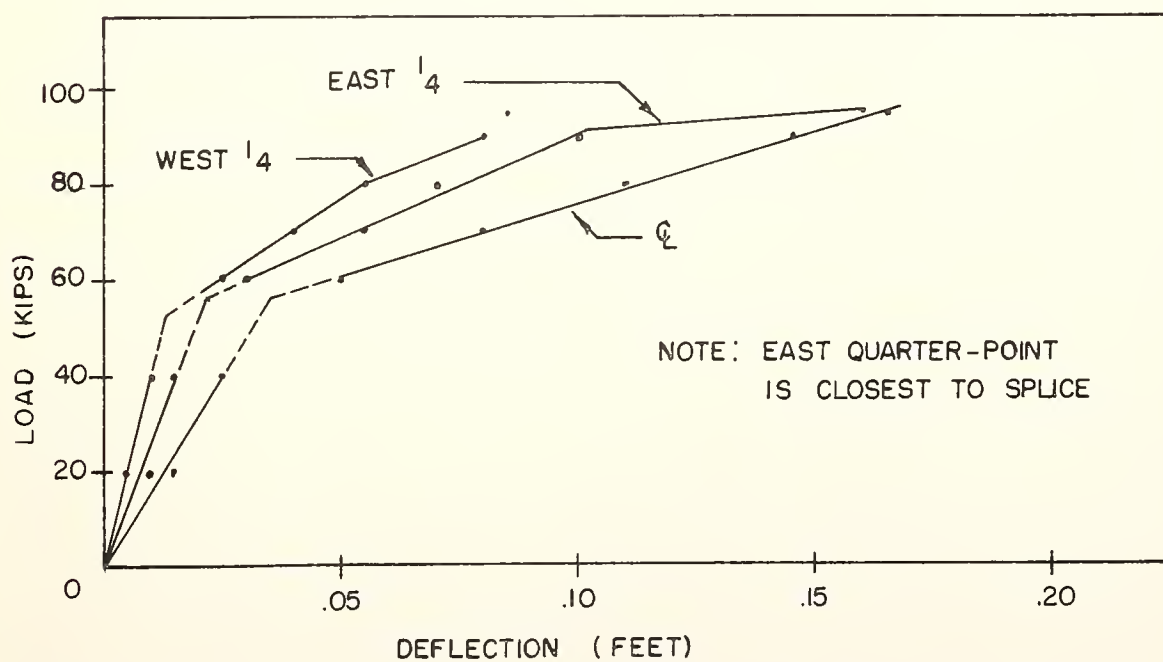
FIGURE 15. CAST-IN-PLACE SPLICE — LOAD VS. DEFLECTION

Figure 15 is a plot of the load-deflection relation obtained at each point. Results at the two quarter-points were significantly different and are plotted separately. The deflection curves are shown dashed in the vicinity of the cracking load. This is an idealization of the member behavior, since no measured data were obtained in this load range. The splice is located approximately at the east quarter-point.

Beam deflections indicated two reasonably linear response curves. Beam stiffness decreased markedly at a load of approximately 60 kips. This load corresponds to the initiation of general cracking in the prestressed member. Deflections at the east quarter-point were greater than those at the west quarter-point at every load level. This behavior is due to the "softer" or non-prestressed concrete at the splice. Deflections at the splice increased rapidly during the load increment which caused failure.

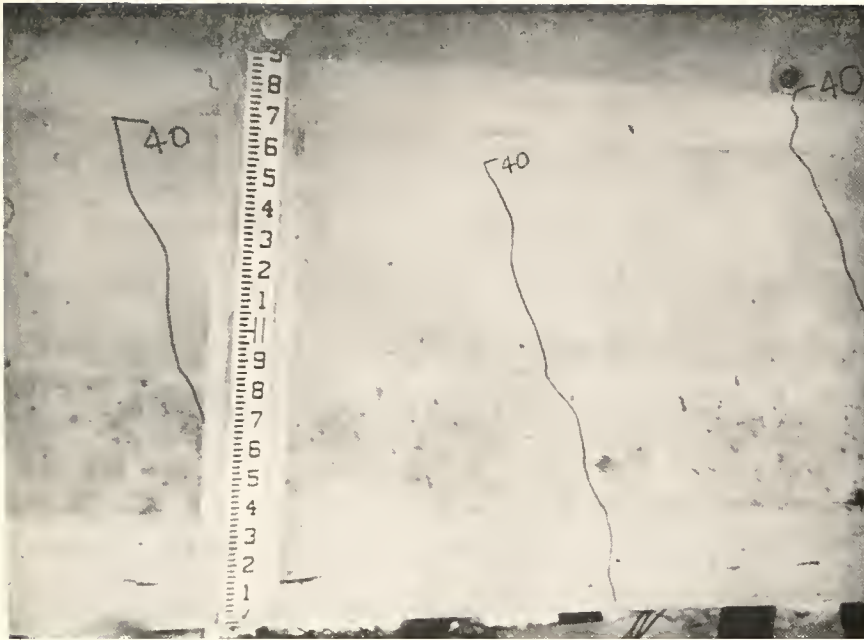
FIGURE 16. CAST-IN-PLACE JOINT AT CRACKING LOAD

The first cracks due to loading occurred in the splice region at a load of 40 kips. Four cracks appeared, at a spacing of about 16 inches. The cracks extended to the junction of the web and upper flange. Figure 16 is a picture of the splice region at this stage of loading. Note that the cracks were traced with a felt marking pen to indicate their position; the actual crack width is very small.

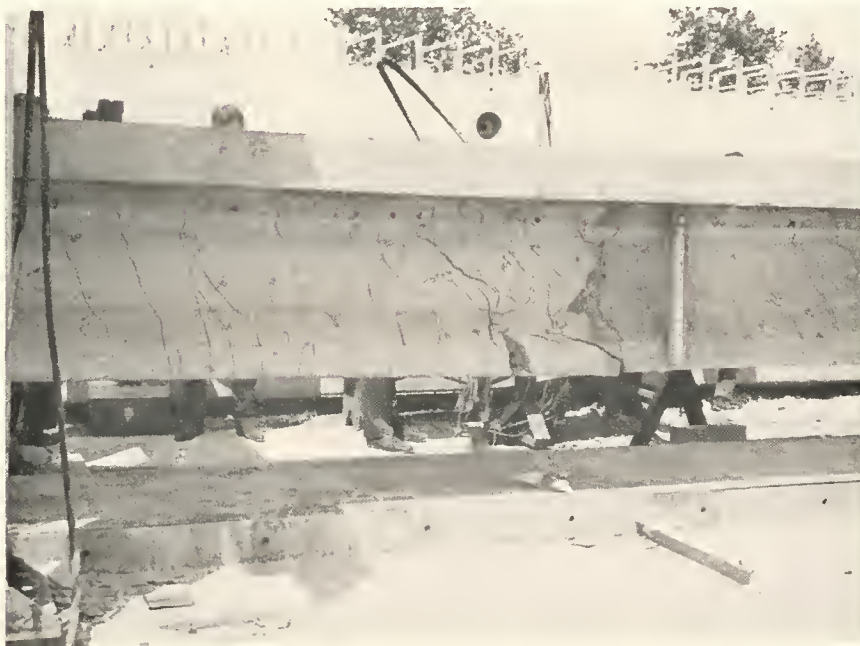
FIGURE 17. CAST-IN-PLACE SPLICE AT FAILURE

The member failed at a load of 96 kips during the next load increment. Failure was sudden and with little warning. The diagonal cracks in the precast portion extended through the bottom flange and widened considerably. Figure 17 is a close-up of the failed region, with the splice at the right and the precast beam on the left. Two major cracks extend from the web cracks—one diagonally through the bottom flange and the other vertically downward.

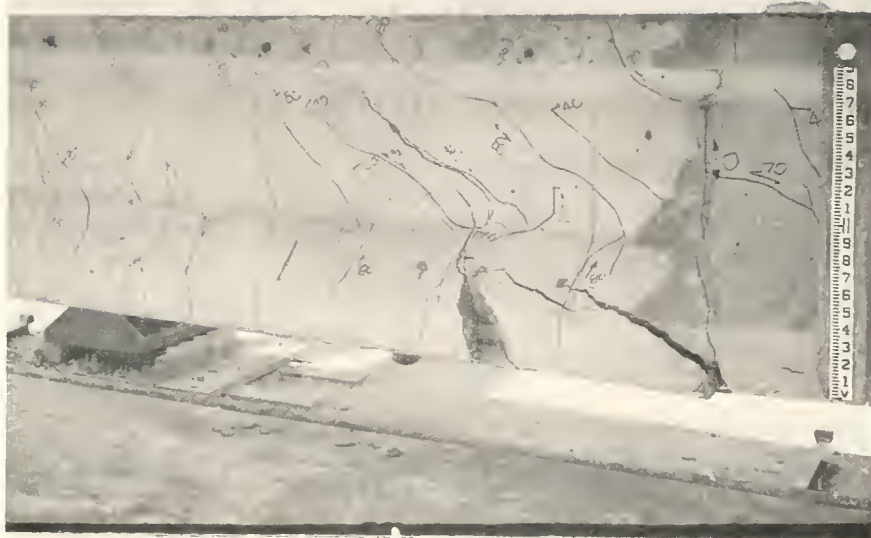
FIGURE 18. CAST-IN-PLACE SPLICE — OVERALL VIEW OF BEAM AT FAILURE

The splice region was in no apparent distress at the time of failure. A few small diagonal cracks had formed, but there was little evidence of impending beam failure in the splice. In other words, it appeared that failure in the splice itself would have occurred at a higher load. Figure 18 is a view of the member after failure, showing the extensive cracking which developed in the precast element and contrasting this with the splice region.

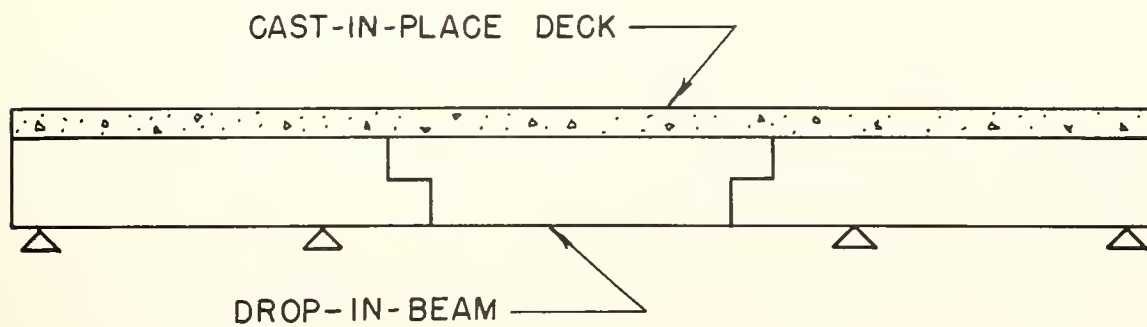
FIGURE 19. DROP-IN-SPLICE — GENERAL ARRANGEMENT

A drop-in splice of the type illustrated in Figure 19 is often used for ease of construction. The joint simply involves placing the drop-in beam on the previously set anchor beams. Dowel rods may be used for alignment or longitudinal shear purposes. An elastomeric pad or cushion may be placed between the bearing faces. The joint is subjected to shear delivered from the supported member.

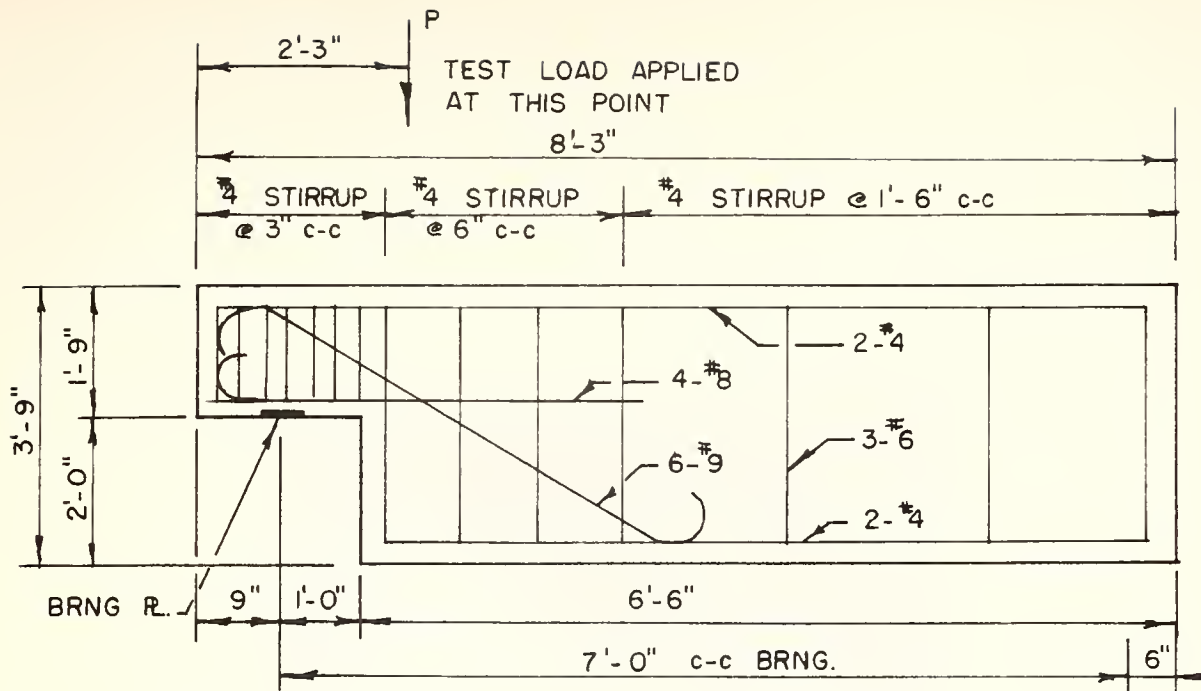
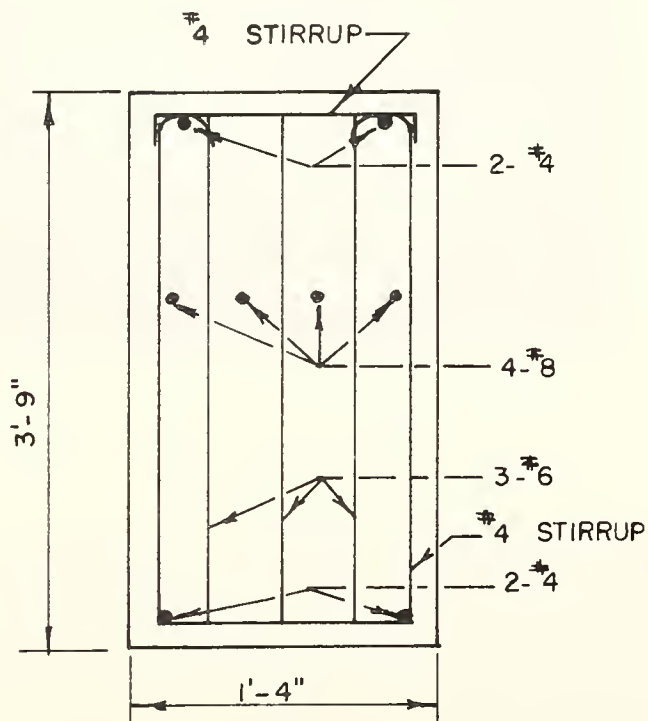
FIGURE 20. DROP-IN SPLICE DETAILS

(A) ELEVATION

(B) SECTION

Figure 20 shows the details of the test specimen and its loading arrangement. A steel bearing plate was cast in the member and used in conjunction with a moveable steel bearing shoe. The beam was cast on May 12, 1969 and was tested at an age of three days. Cylinder compressive

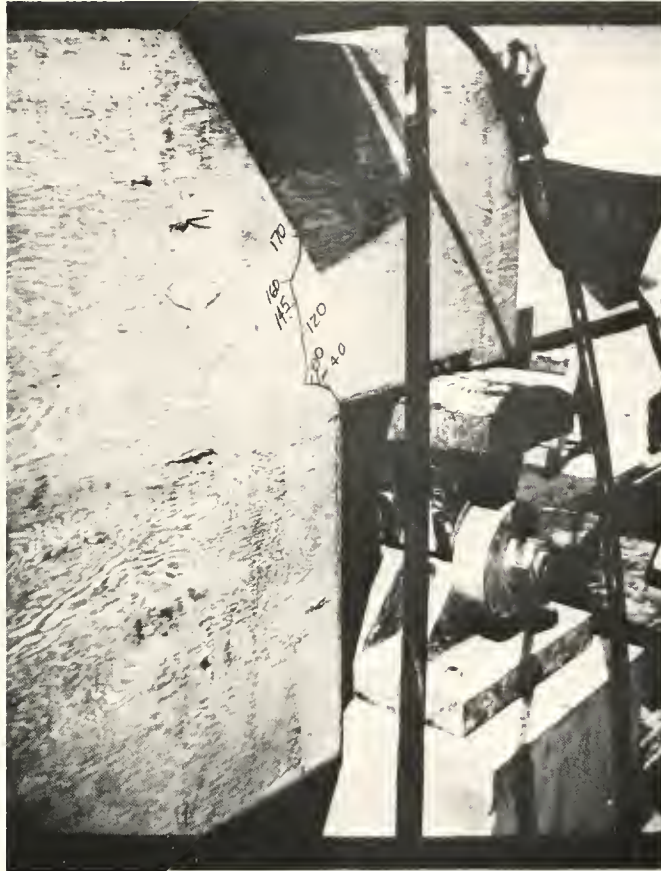
FIGURE 21. DROP-IN SPLICE AT END OF TEST

A photograph of the beam in test position is presented as Figure 21. The load was applied in increments to 170 kips. An extremely small crack at the re-entrant corner occurred at a load of 40 kips. The crack gradually extended to the position seen in the figure at the end of the test. Crack width was very low at all times - measured width was 0.003 inches at a load of 145 kips. The test was halted at the 170 kip load, since this was approaching the useful capacity of the test frame. The joint gave no indication of distress and the loading was apparently well below the failure capacity of the member.
